DEPARTMENT OF TRANSPORTATION**DIVISION OF ENGINEERING SERVICES**

Contract #: 04-0120F4Cty: SF/ALA Rte: 80 PM: 13.2/13.9File #: 1x.28**WELDING INSPECTION REPORT****Resident Engineer:**Pursell, Gary**Address:** 333 Burma Road**City:** Oakland, CA 94607**Report No:** WIR-013837**Date Inspected:** 28-Apr-2010**Project Name:** SAS Superstructure**OSM Arrival Time:** 700**Prime Contractor:** American Bridge/Fluor Enterprises, a JV**OSM Departure Time:** 1200**Contractor:** American Bridge/Fluor Enterprises, a JV**Location:** Job Site**CWI Name:** Tony Sherwood**CWI Present:** Yes No**Inspected CWI report:** Yes No N/A**Rod Oven in Use:** Yes No N/A**Electrode to specification:** Yes No N/A**Weld Procedures Followed:** Yes No N/A**Qualified Welders:** Yes No N/A**Verified Joint Fit-up:** Yes No N/A**Approved Drawings:** Yes No N/A**Approved WPS:** Yes No N/A**Delayed / Cancelled:** Yes No N/A**Bridge No:** 34-0006**Component:** OBG Sections**Summary of Items Observed:**

WELDING INSPECTION REPORT

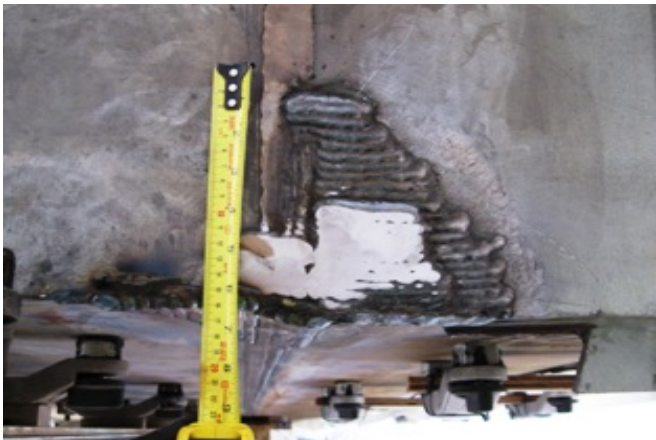
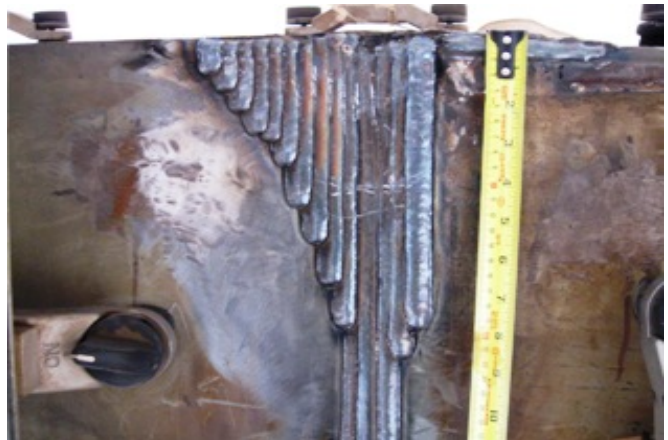
At E3/E4 –E and F (E-side plate and F-edge plate) this QA Inspector randomly observed QC Inspector Jim Cunningham and ABF welding personnel Rory Hogan (#3186) and Jeremy Dolman (#5042). During the first observation at this location welding was not being performed and QC Inspector Jim Cunningham informed this QA Inspector welding would begin at approximately 1030 hours (after the morning break). This QA Inspector returned to this location at approximately 1030 and observed welding had started. This QA Inspector observed the Bug-O track system was not being used and ABF welding personnel Jeremy Dolman (#5042) was using the Flux Cored Arc Welding (FCAW) process by hand. The welding was being performed at E3/E4-F (edge plate) and QC Inspector Jim Cunningham was present monitoring the welding parameters; 218 amperes and 24.1 volts at a travel speed of 186 mm per minute. QC Inspector Jim Cunningham stated welding was being performed on the transition area between OBG sections E3 and E4 using WPS - ABF-WPS-D15-3042B-1. The area welding was being performed at had limited space for access with ABF welding personnel Jeremy Dolman (#5042) performing the welding and Rory Hogan (#3186) assisting. This QA Inspector returned to this location later in the shift and observed the Bug-O track system was now being used to weld on E3/E4-E (side plate). The welding being performed was on the base material adjacent to the groove and when this QA Inspector asked QC Inspector Jim Cunningham the purpose of this welding the QA Inspector was informed ABF welding personnel had been instructed to proceed with welding a transition area to compensate for the offset between E3 and E4 at these locations. The QA Inspector asked if a Request For Information (RFI) had been submitted regarding the welding and the use of the groove welding WPS for the work being performed. QC Inspector Jim Cunningham informed this QA Inspector a RFI had been submitted, but that an answer had not been received and that ABF had elected to proceed at their own risk. This QA Inspector informed QA Inspector's Rick Bettencourt and Danny Reyes of the observation. Please see photos below of the areas welded below. The area on side plate (E) is approximately 100 mm wide and 190 mm long and on edge plate (F) 125 mm wide and 150 mm long.
